Appendix E2 – Restoration Plans and TMDLs (Restoration Plans)

Watershed Restoration Project Monitoring - Woodbridge

Woodbridge Year 1 Post-construction Monitoring

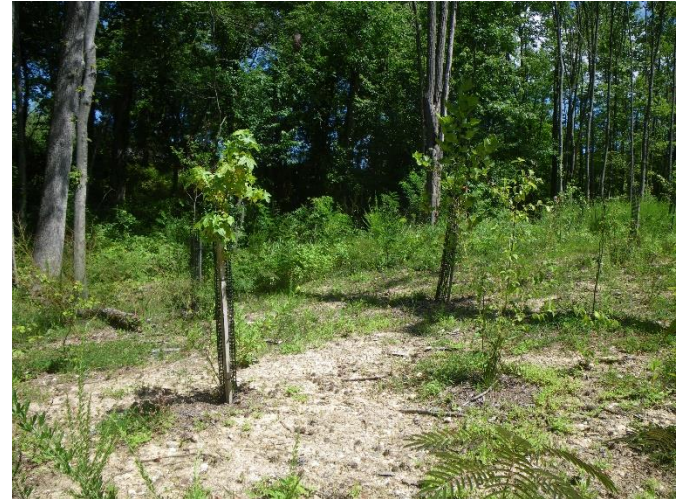
View of poor herbaceous establishment on right bank from station 2+00

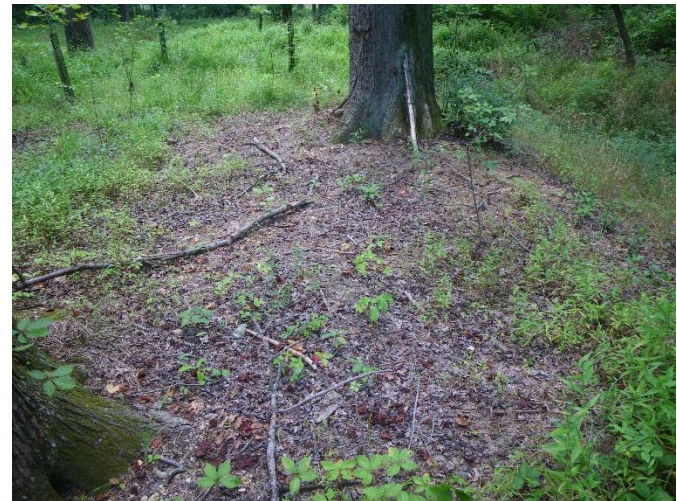
View of bare spot around existing trees on left bank from station 5+25 to 5+50

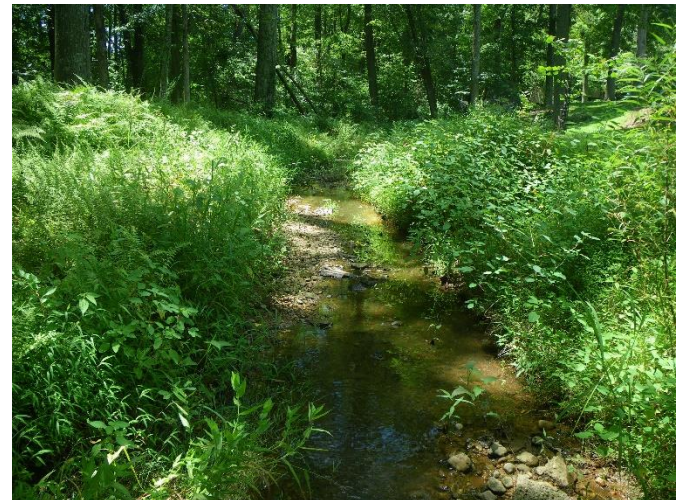
View facing upstream from station 11+25

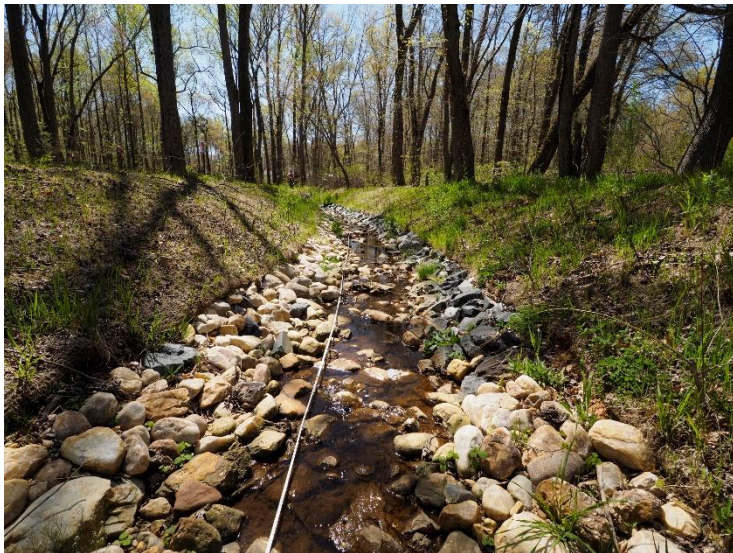
Station 4+65 facing downstream

Station 4+65 facing right bank stone toe protection; small scour at key-in but cause uncertain, otherwise stable

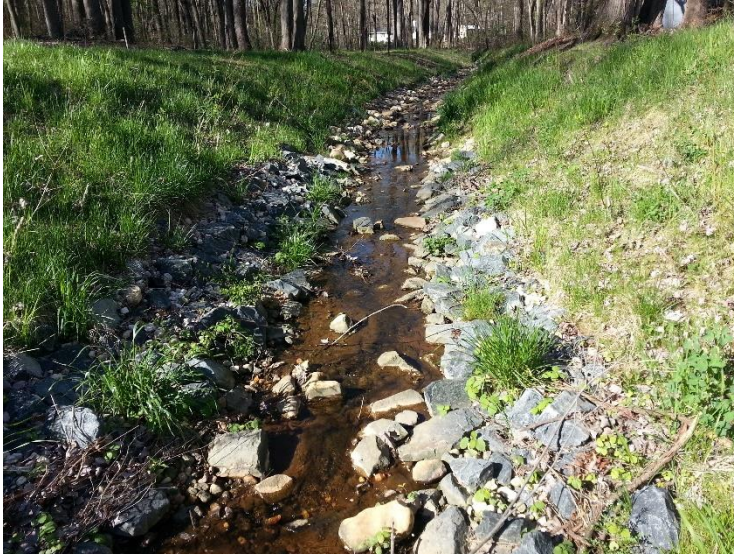
Station 3+20 facing downstream; riffle grade control is stable

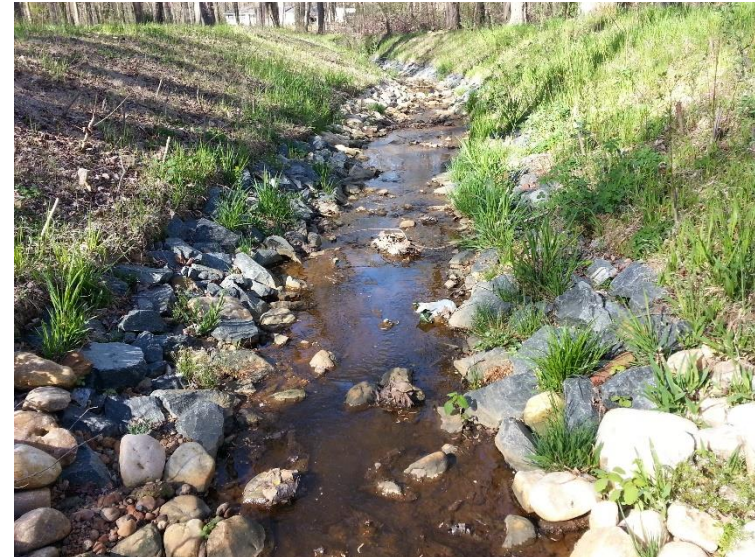
Station 4+25 facing downstream; riffle grade control stable with good side slope correction; no scour at downstream end

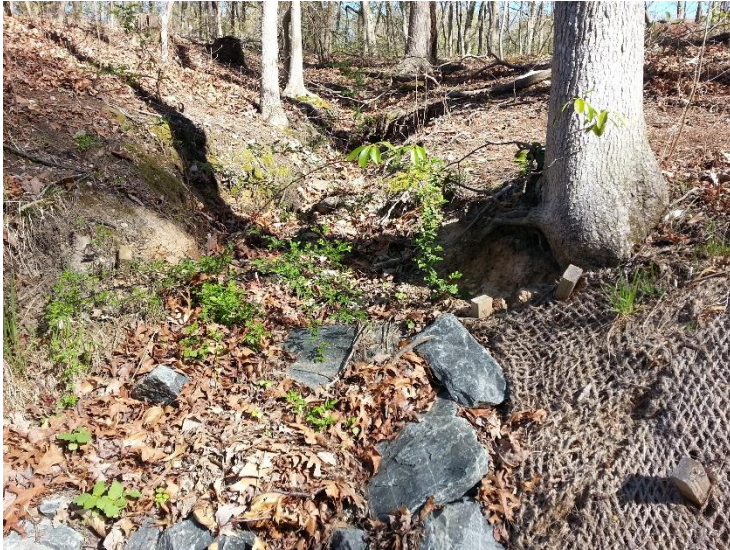
Station 7+51 facing right bank seep channel; tie-in is stable

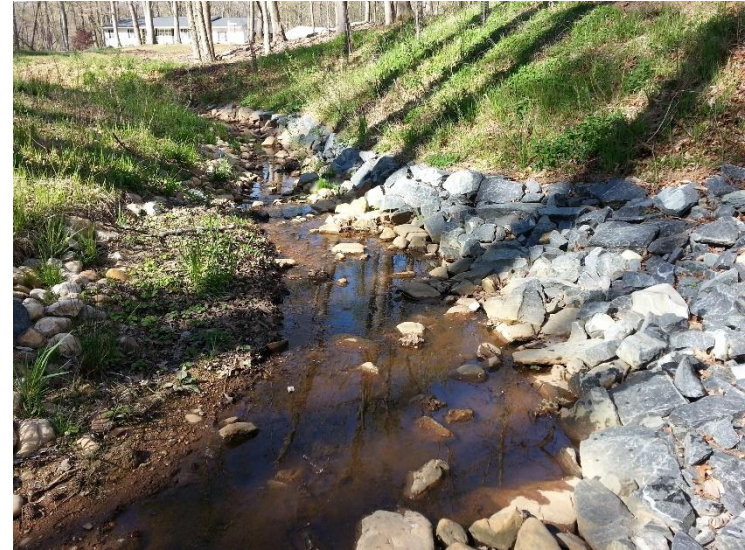
Station 7+51 facing downstream; stone toe protection and seep channel tie-in is stable with some deposition

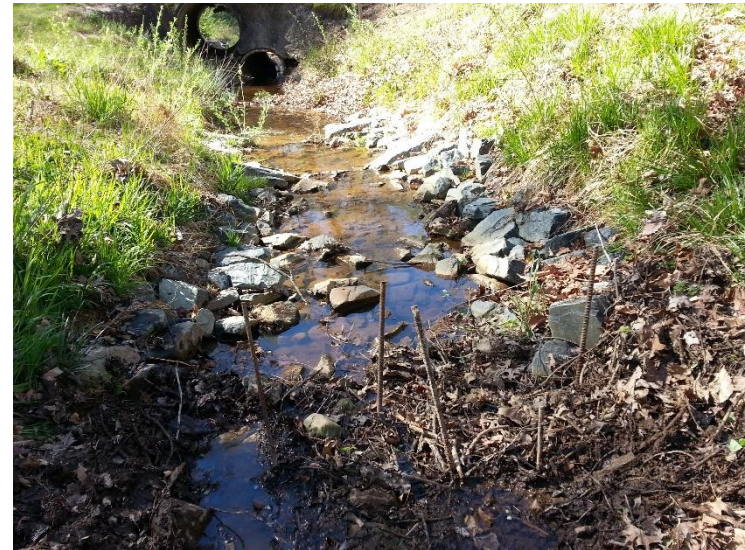
Station 8+30 facing downstream at debris collector installed by property owner
